Chris Sorell
123 Inspector Road
Saratoga Springs, 12866
HIN™: 128667195
Email: chrisorell@gmail.com
Inspection Date: 08-13-2016

MLS-Saratoga Home Inspections
Chris Sorell
1 Whitney Road S Saratoga Springs, New York 12866
Phone: (518) 330-2004
E-Mail: chrisorell@gmail.com

— Report Summary

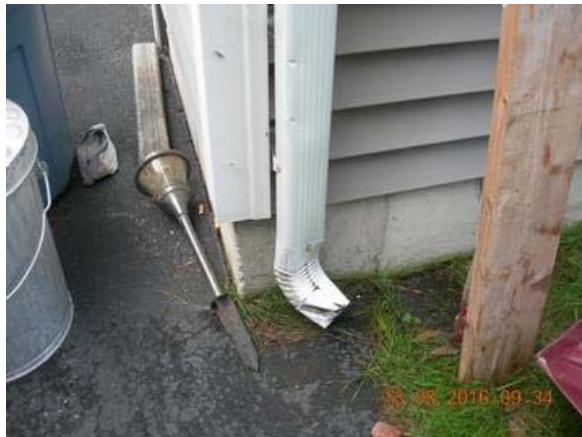
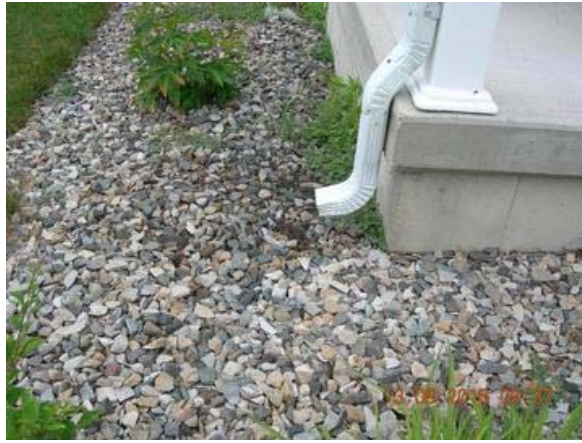
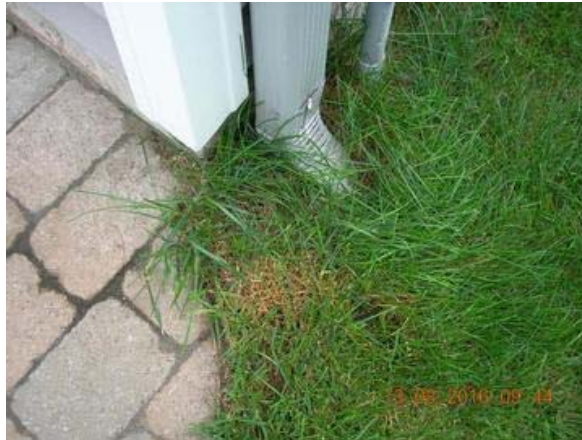
Gutters had extensions, but they were not long enough to get water away from the foundation. Recommend a qualified contractor install gutter extensions.

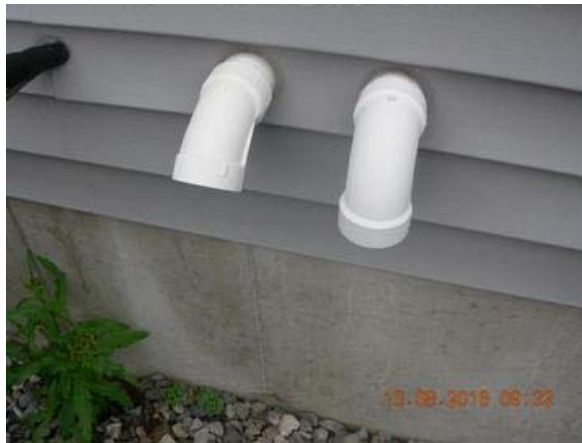
High efficiency pipes are too close together and both angled down. This could allow a back draft of carbon monoxide into dwelling. Recommend a qualified contractor repair as necessary.

Both angled down

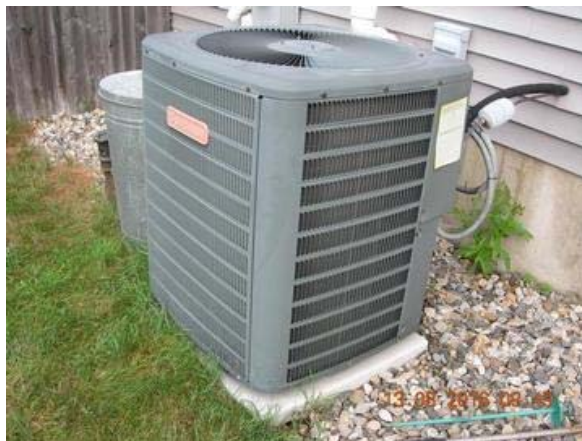
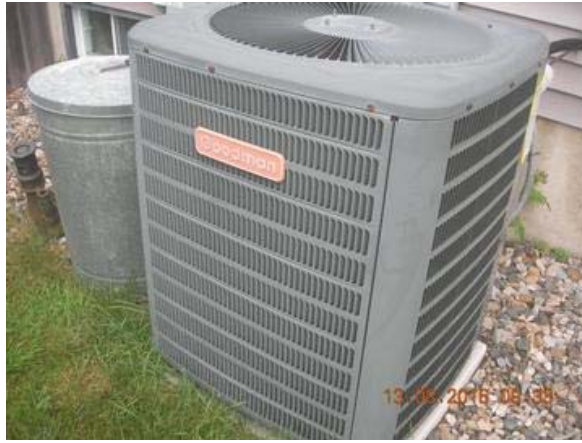
The support pad for the A/C compressor is out of level. This can lead to unbalanced loads for any motors or fans, Possibly causing the premature wear of belts an/or bearings in the compressor motor. Recommend a qualified contractor evaluate and make necessary repairs.

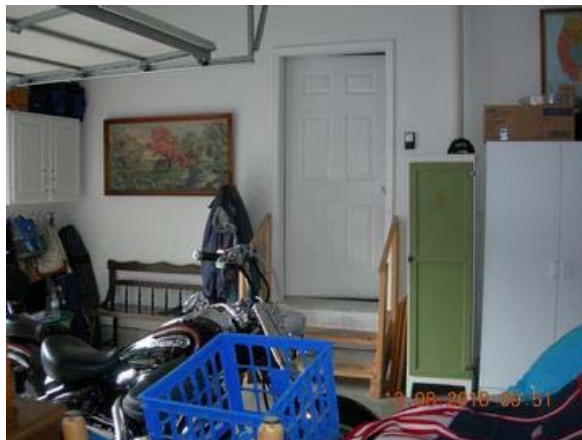
Garage-house door isn't auto-closing. Recommend installing hinges with springs or an automatic door closing device so door closes automatically to prevent vehicle fumes from entering building.

Does not self close

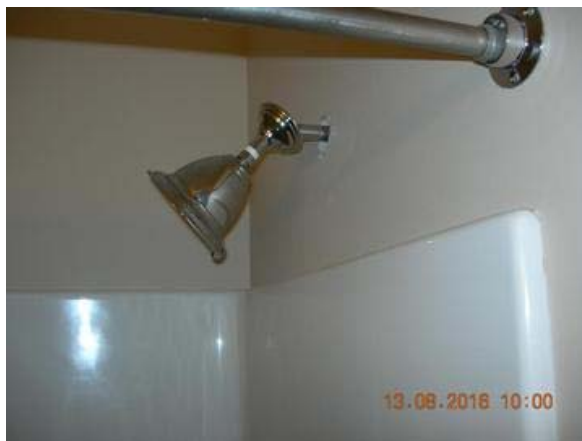
Noted the shower head was pulled away from the wall. This could allow water getting behind the shower wall. Recommend having a qualified contractor repair as necessary.

Head away from wall

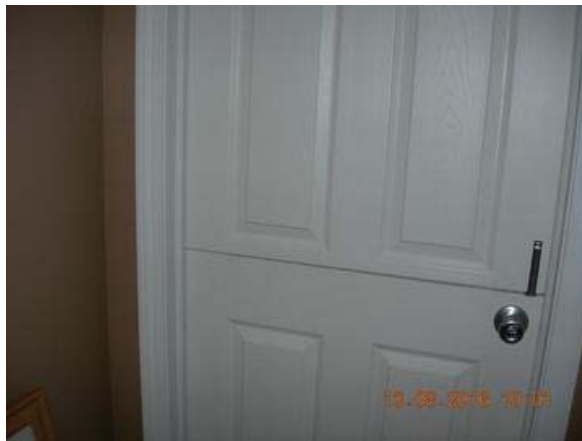
08/13/2016 One of the three bedrooms weren't inspected at the time of the inspection.

Bedroom not inspected

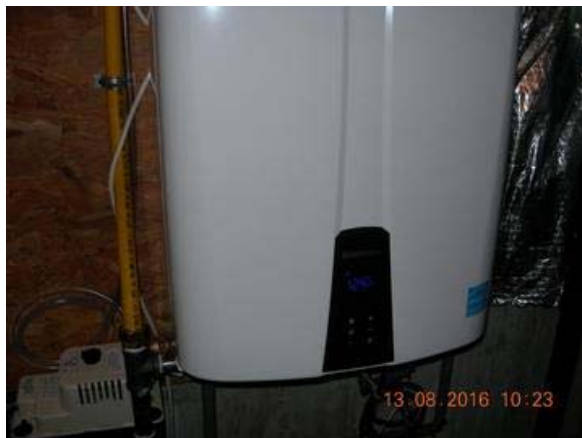
08/13/2016 Hot water heater on demand unit operated as designed on the day of the inspection.

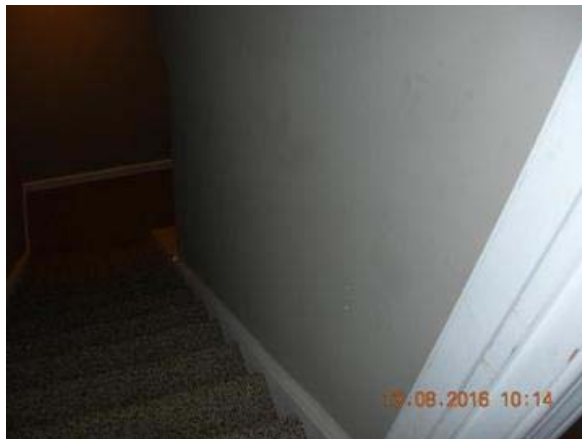
No handrail noted on basement steps. This is a safety hazard and may lead to serious injury. Recommend repair by a qualified contractor.

08/13/2016 No handrail noted on basement steps. This is a safety hazard and may lead to serious injury. Recommend repair by a qualified contractor.

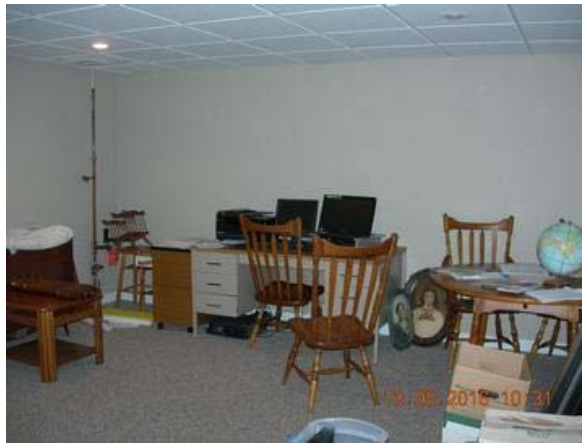
Finished Basement

08/13/2016 Recreational space noted in the basement. In the event that this space used as a living space, a secondary emergency egress would be needed.
